STRUCTURAL AUDIT: 2019-2020

VISUAL INSPECTION REPORT FOR:
St. XAVIER'S COLLEGE
5, MAHAPALIKA MARG, MUMBAI 400001

Prepared by: Mr. Dhananjay Demse (VMS CONSULTANTS PVT. LTD)

Project Name : Visual Inspection for St. Xavier's College
Date of inspection : 27-09-2019 to 05-10-2019
Present: : Mr. Kamal (Administrator- Xavier's College)

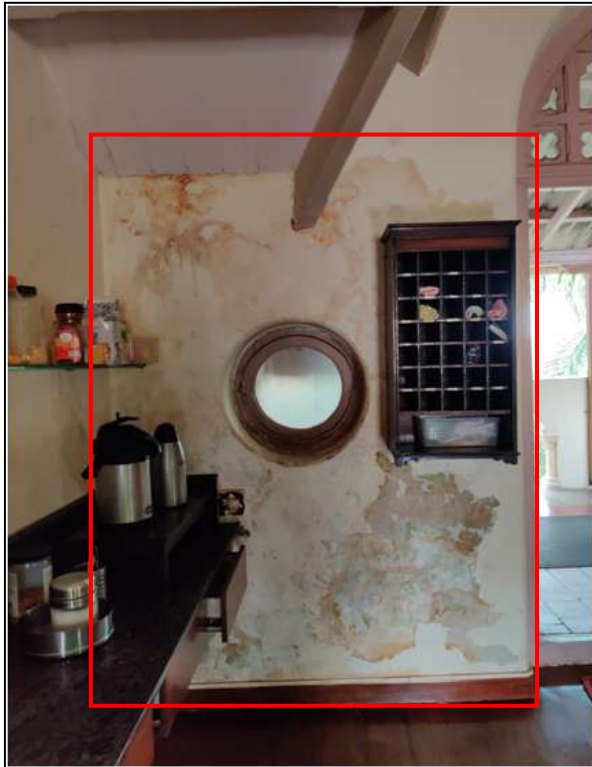
1. Dampness on walls observed due to Leakage from roof / wall.
2. Windows frames were damaged due to leakages from the wall
3. Cracks in columns, beams & slab of corridor between the office building and Chapel due to corrosion of reinforcement in concrete
4. Reconstructed mezzanine with structural steel. (Ground Floor)

Fig 2. Dampness and leakage marks on third floor Dining room admin building

2. Leakages can be arrested the proper water proofing, sealing of joints in the wall, filling the gaps between the window frames and masonry wall.
3. Further investigation is required for the gap/cracks between the science building and library building.

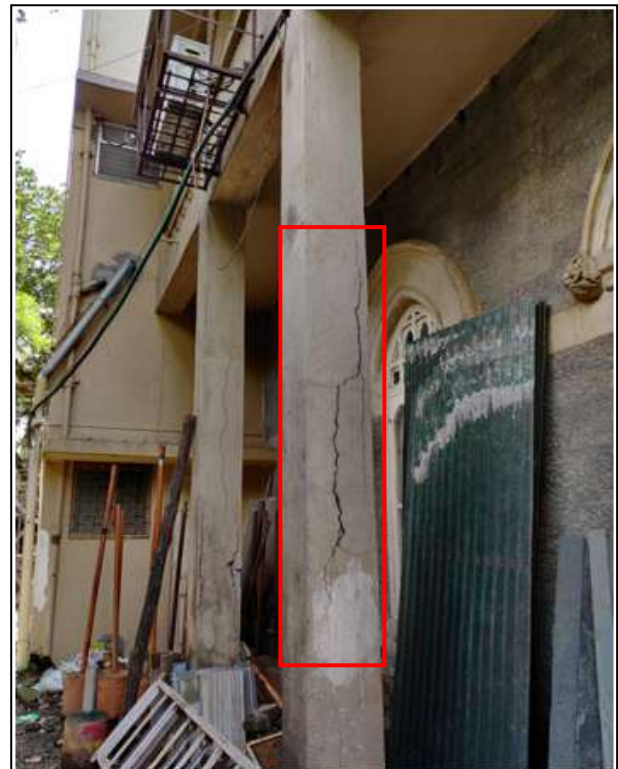
Fig 3. Vertical deep crack in column passage between the admin building and Chapel

1. Cracks in columns, beam & slab of corridor between the office building and Chapel.
2. Separation crack in connection between hall & science building.
3. Steel trusses supporting terrace slab and vault (arch slab of chapel). Steel members of trusses that are badly corroded.
4. Cover concrete of vault that is spalling and the reinforcement that is corroded.
5. Exposed Reinforcement in Slab of Chapel Building (First floor) Inter-Religious Study Department
6. Termite attack in the inter-religious study department
7. Leakage marks and dampness on walls in Blatter Herbarium department. Cause Leakage through external wall- Social Science Building
8. Leakage observed through expansion joint in the passage area between science building and XIMR building.
9. Exposed reinforcement in slab of toilet area.
10. Major leakage in room no. 520.

1. From the visual observation we find that in most of the places where reinforced concrete has been used, there are durability issues such as spalling of cover concrete and corrosion and exposure of reinforcement. We suggest that these structural members shall be thoroughly repaired with polymer mortar, epoxy mortar and micro concrete depending upon the gravity of the damaged/distress in the member. Detailed measures can be decided only after opening of the cracks in column, beam and slab.

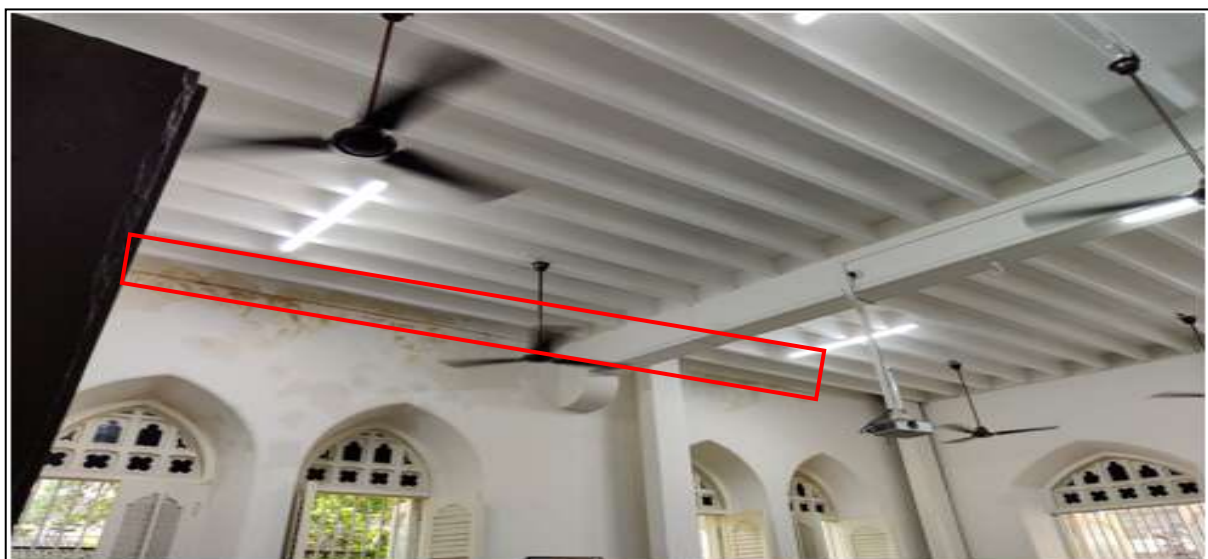
Fig 4. Dampness and leakage marks on first floor office building

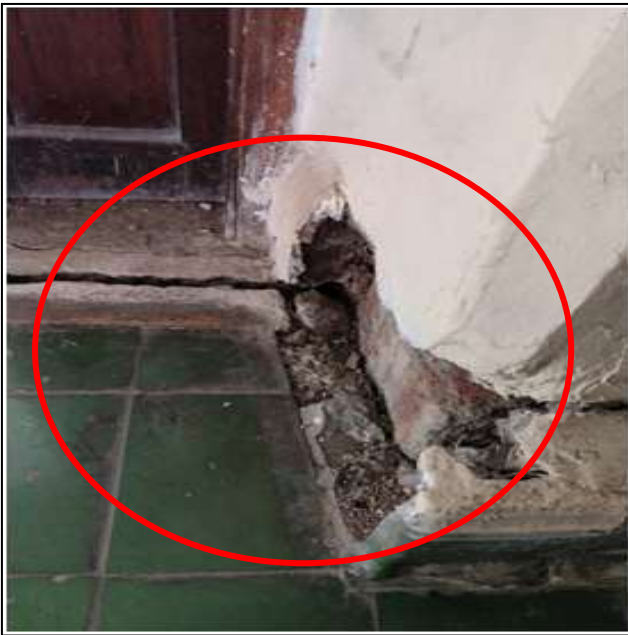
The joint between the science building and the hall has been a source of cracks, and settlement due to the movements of the two buildings at the point since many years. A comprehensive long-term solution needs to be agreed upon, to address the niggling problem.

1. Separation crack in connection between hall & science building due to outward movement of science building that creates stress at the connection of both buildings. **Requires further investigation.**
2. Uneven floor surface in the passage area towards science building due to movement of science building.
3. Reinforcement is exposed and plaster is falling in the staircase area between the hall building and Science Building-B due to leakages. Reinforcement is corroded.
4. Bulging observed in the column of physics lab Ground floor science building B
5. Leakage is observed in the staircase area from terrace floor to ground floor

Fig 5. Cracks observed in the floor and wall near the separation crack in hall & science building

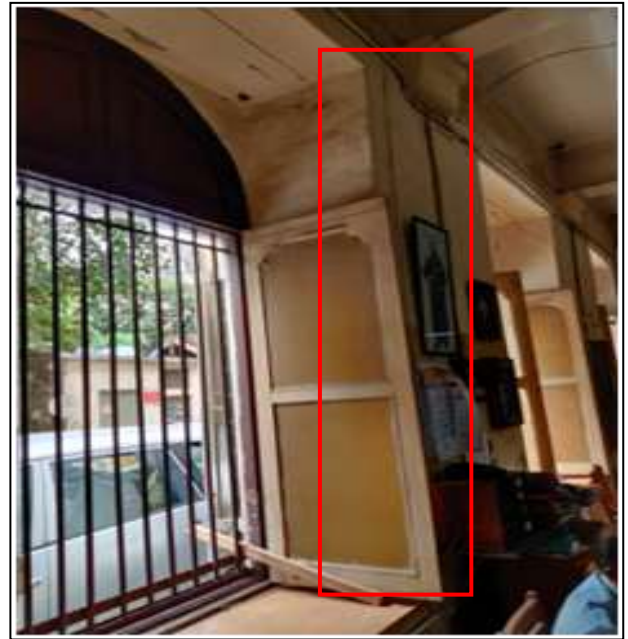
Fig 6. Bulging observed in the column of physics lab Ground floor science building B

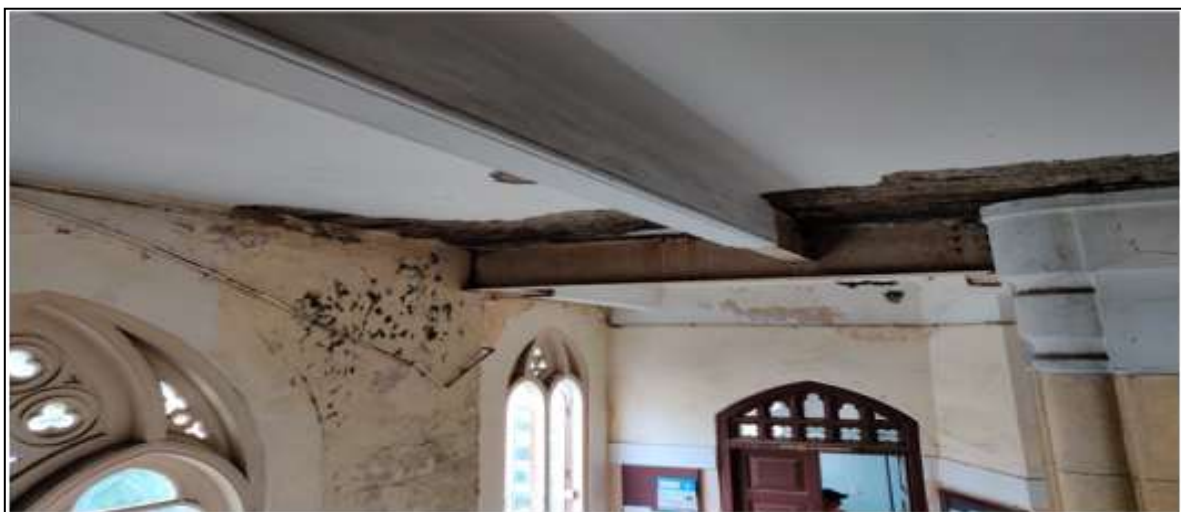
Fig 7. Reinforcement is exposed and plaster is falling in the staircase area between the hall building

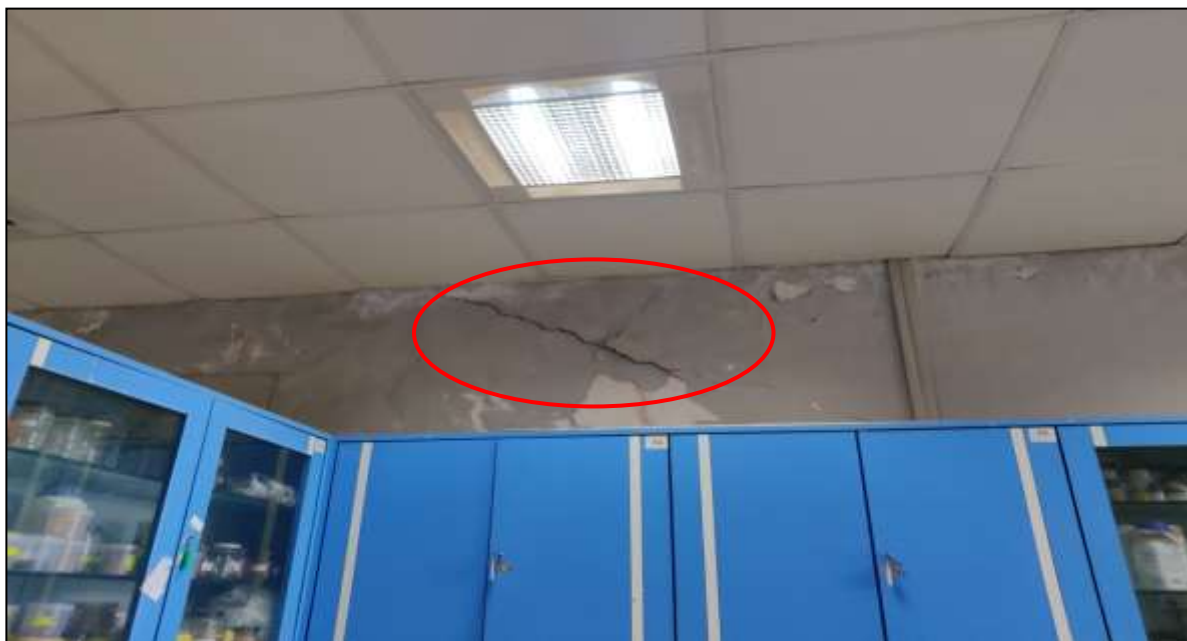
1. Deep Crack observed in the wall of Botany Laboratory 1 external wall. (Fourth Floor)
2. Major leakage and dampness observed in botany laboratory 1. (Fourth Floor)
3. Leakage marks and dampness observed on walls in Blatter Herbarium department. Due to Leakage through external wall.
4. Leakage observed near the W.C. area in staircase passage due to leakage through the sunken area.

Fig. 8. Deep Crack in the wall of Botany Laboratory 1 external wall (Fourth Floor) Social Science Centre Building

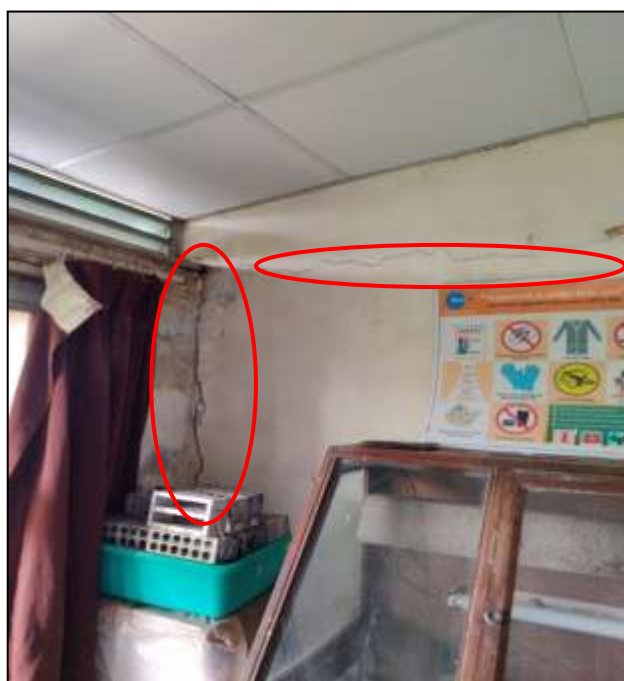
Fig. 9. Vertical and Horizontal deep separation crack in external wall of Botany Laboratory. (Fourth Floor) Social Science Centre Building

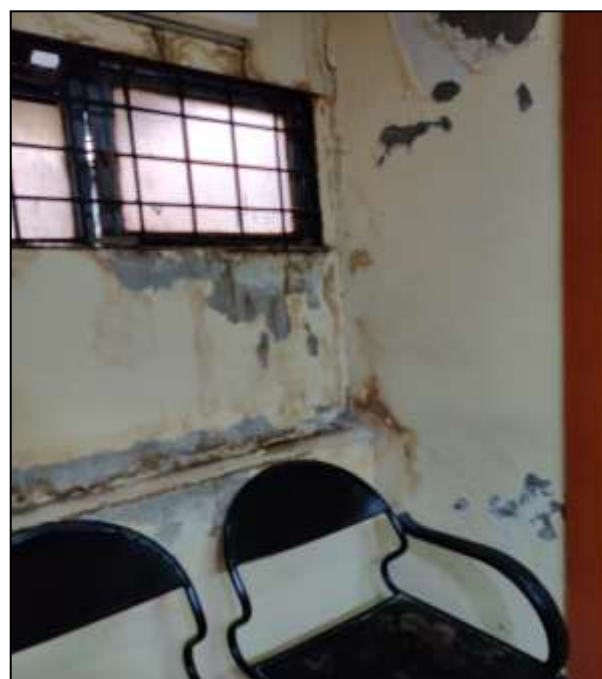
Fig. 10. Leakage and dampness observed in the Bank (lecture room no.4) on the external wall

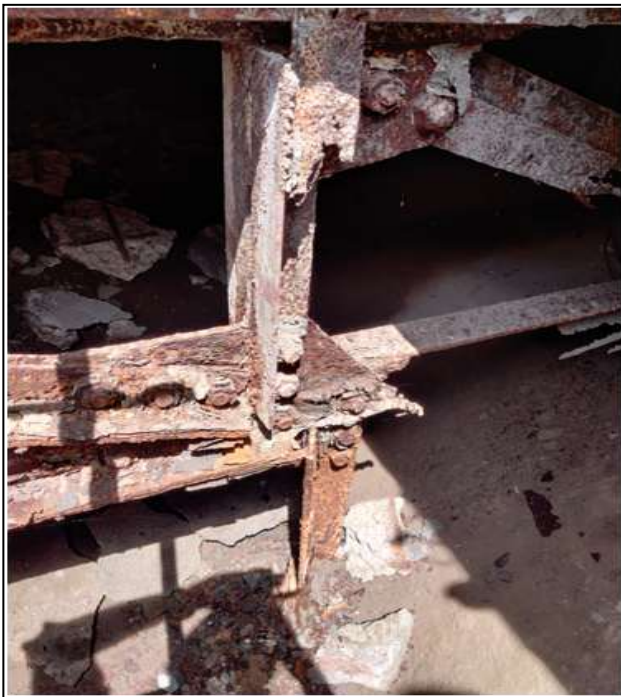
1. Steel trusses are supporting the terrace slab and vault (arch slab of chapel). Steel members in the trusses are badly corroded. Cover concrete of vault is spalling. Reinforcement is corroded.
2. Major distresses found in Passage (1m. wide) Chapel Building First Floor due to corrosion of reinforcement in concrete.
3. Slab Reinforcement is exposed at ground floor ceiling in Inter-Religious Study Department due to spalling of cover concrete.
4. Termite attack in the inter-religious study department is noted, needs immediate attention.

Fig 11. Rusting of Structural Steel Members above vault.

4. Strengthening / replacement of the steel trusses is required in chapel building
5. Urgent repair of vault is suggested.
6. Routine audit and repairs of the campus is suggested.

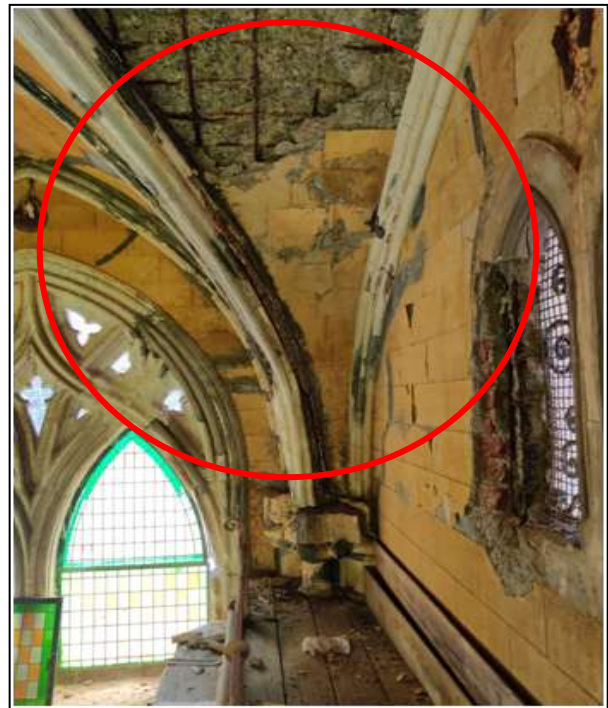
Fig 12. Exposed reinforcement in loft area and falling of concrete.

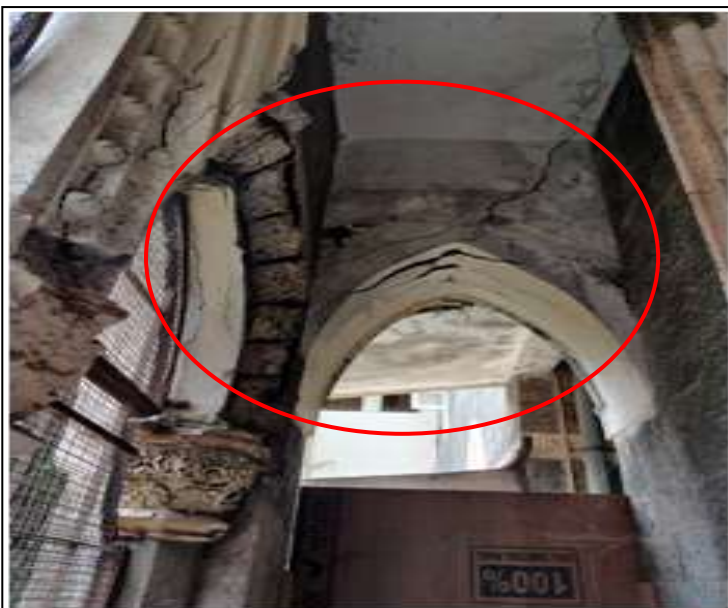
Fig 13. Major distresses found in Passage (1m. wide) Chapel Building First Floor.

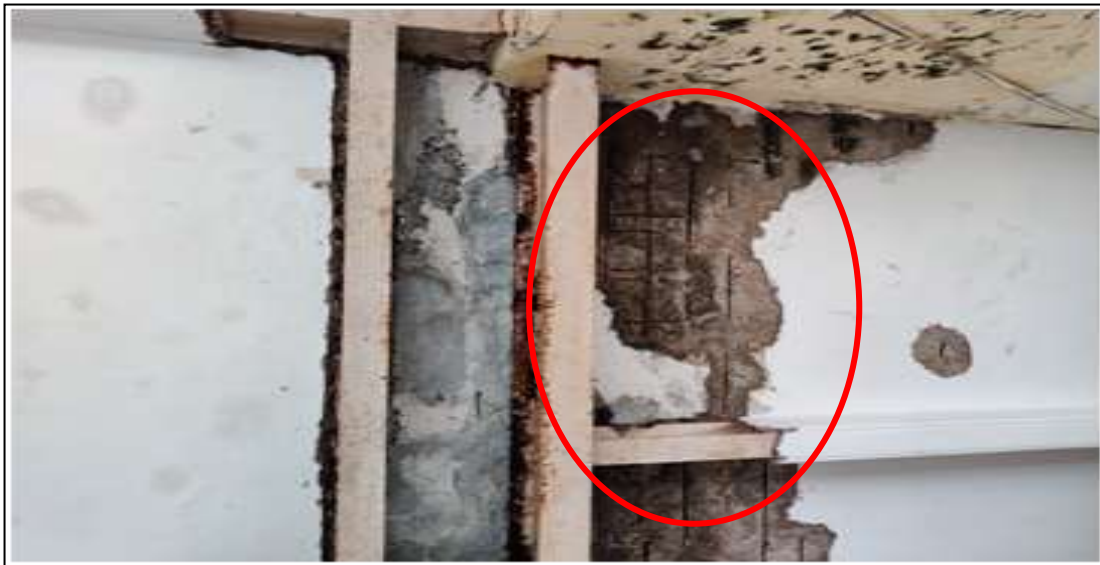
1. Floor landing slab reinforcement is exposed due to spalling of cover concrete in between Hall Building and Science Building staircase area.
2. Slab reinforcement in the staircase section is exposed between Hall Building and Chapel Building at 2nd floor.
3. Dampness on window jambs of Library (First Floor) Hall Building due to leakage from external wall.
4. Cracks observed in column at Vault.
5. Vertical Crack in column of Makeup Room is noted; this may be due to corrosion of reinforcement in concrete.

Fig 14. Exposed reinforcement in landing area of stair case between Hall Building and Science Building

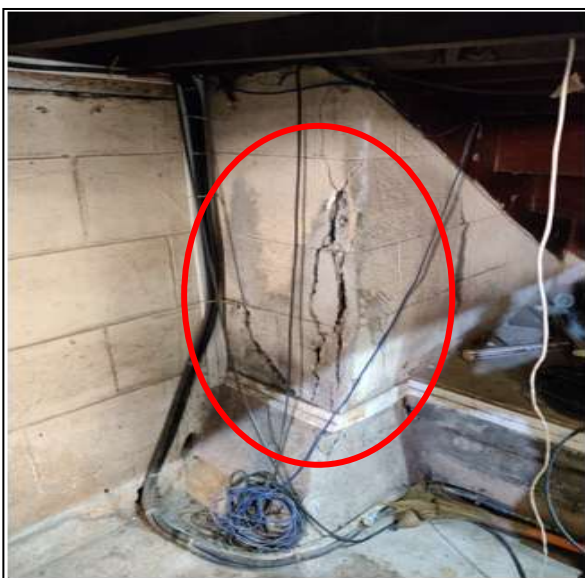
Fig 15. Vertical Deep Crack in column Makeup Room (Ground Floor)

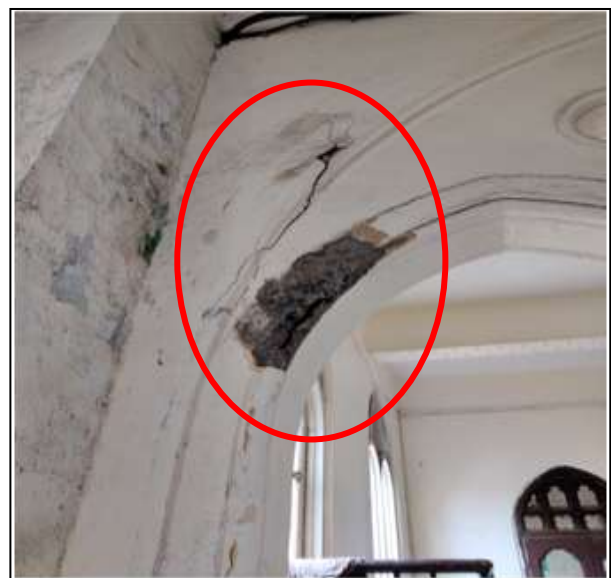
Fig. 16. Exposed reinforcement in the staircase section between Hall Building and Chapel Building at 2nd floor

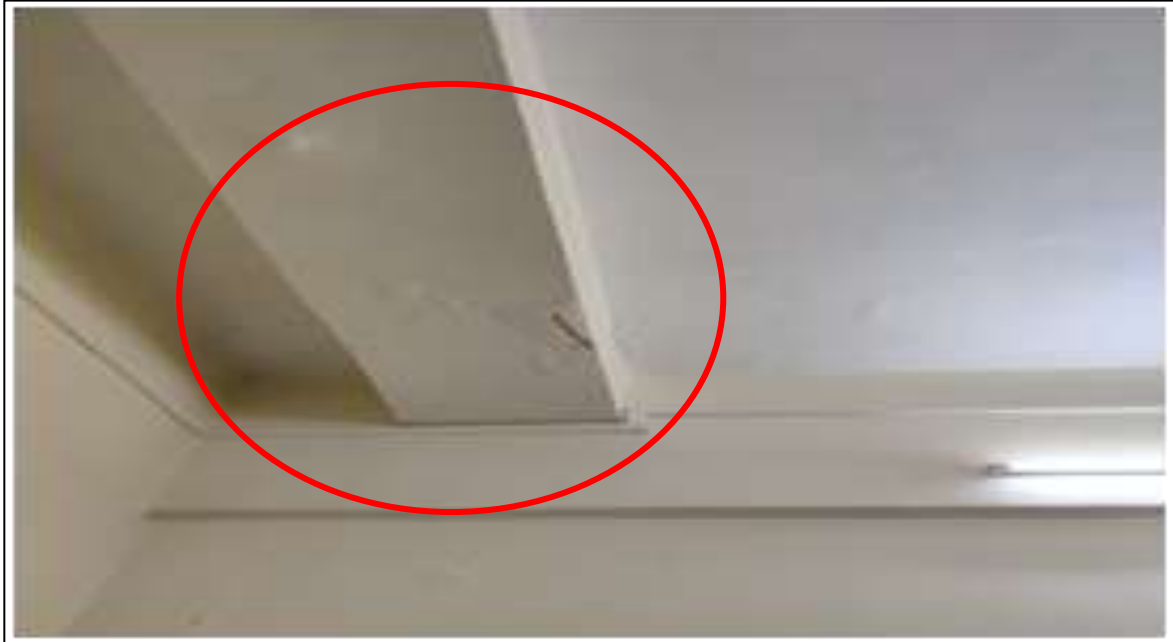
1. Major leakage in office area at 2nd floor due to leakage from overhead water tank bottom slab.
2. Leakage marks are observed in the staircase area from 2nd floor to 1st floor.
3. Peeling of paint observed in badminton court.

Fig 17. Major leakage in office area 2nd floor, Gymkhana Building

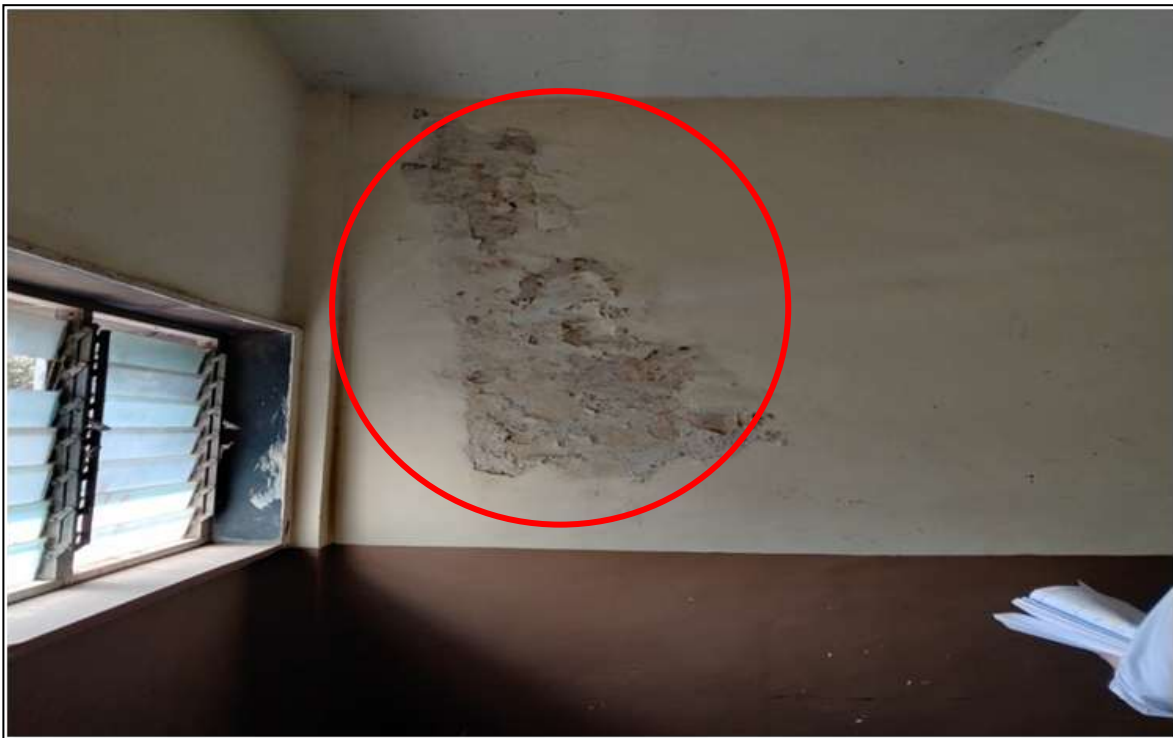
Fig 18. Leakage marks are observed in the staircase area from 2nd floor to 1st floor

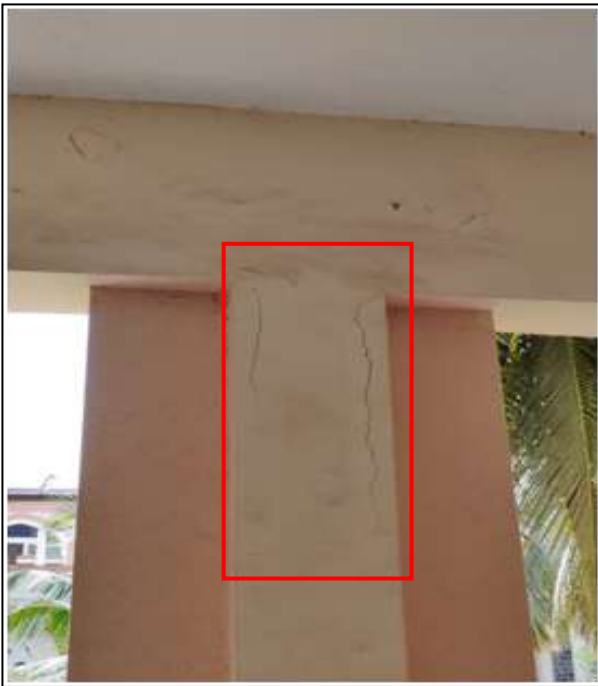
1. Leakage observed through expansion joint in the passage area between science building and XIMR building.
2. Delaminated plaster is observed in the Passage area.
3. Vertical crack in column in Indoor games room at first floor noted
4. Vertical cracks observed in columns in passage area. These cracks are due to corrosion of reinforcement bars in concrete.

Fig 19. Vertical crack observed in column below the column beam junction 2nd floor passage area

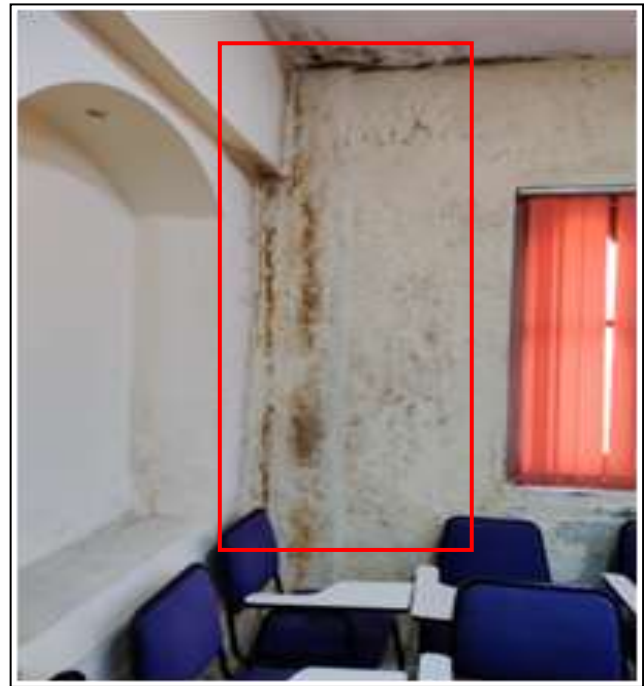
Fig 20. Leakage observed in the wall in the portion near Expansion gap between science building and XIMR building

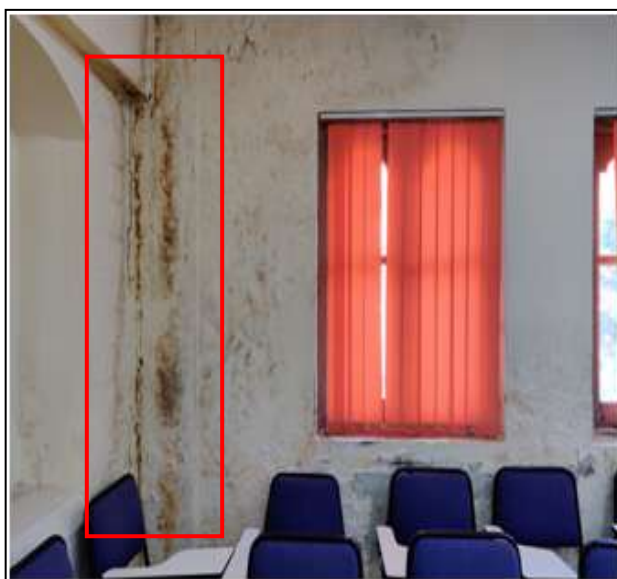
Fig 21. Leakage observed in the wall in the portion near Expansion gap between science building and XIMR building

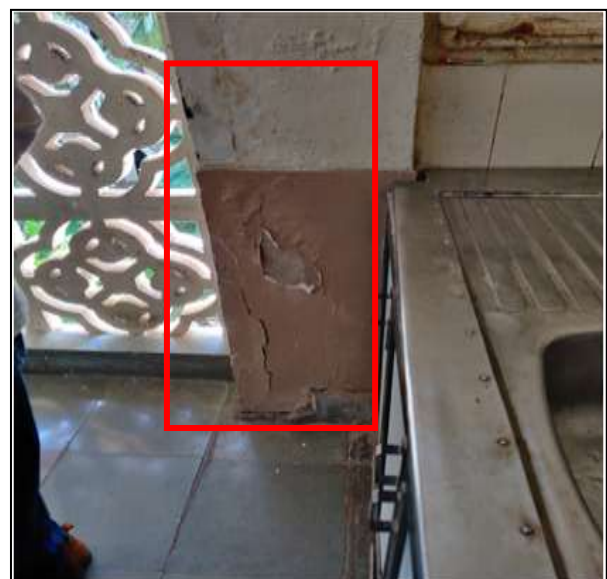
Fig 22. Vertical crack at floor level and Colour peeled off near the expansion joint

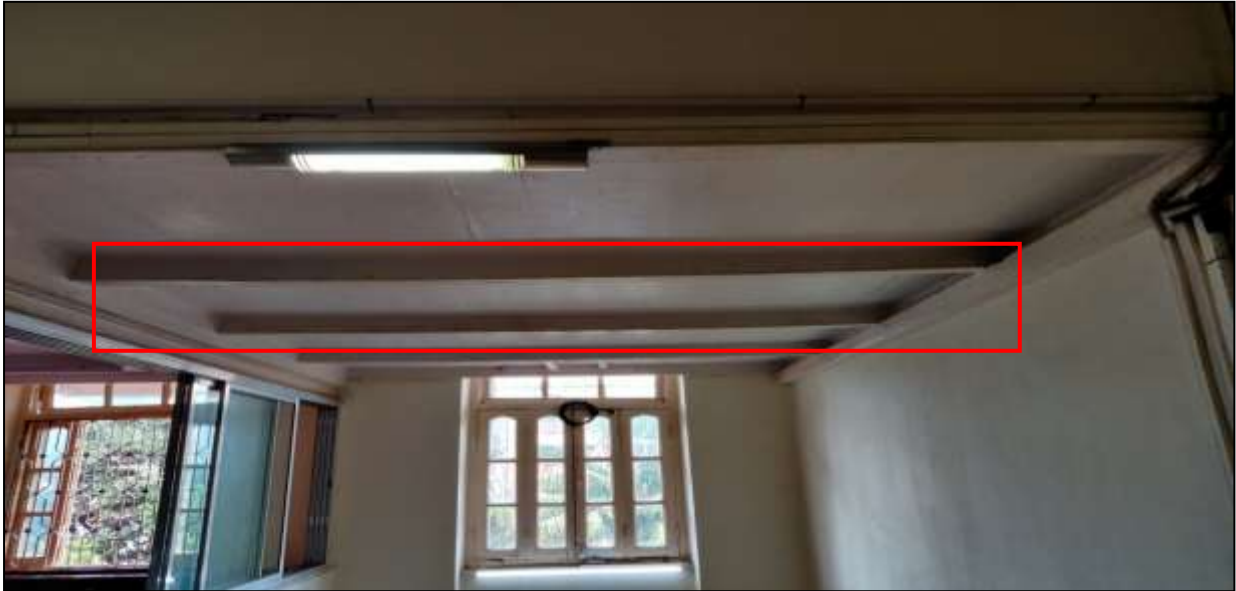
Fig 23. Sagging observed in the wooden beam above staircase area

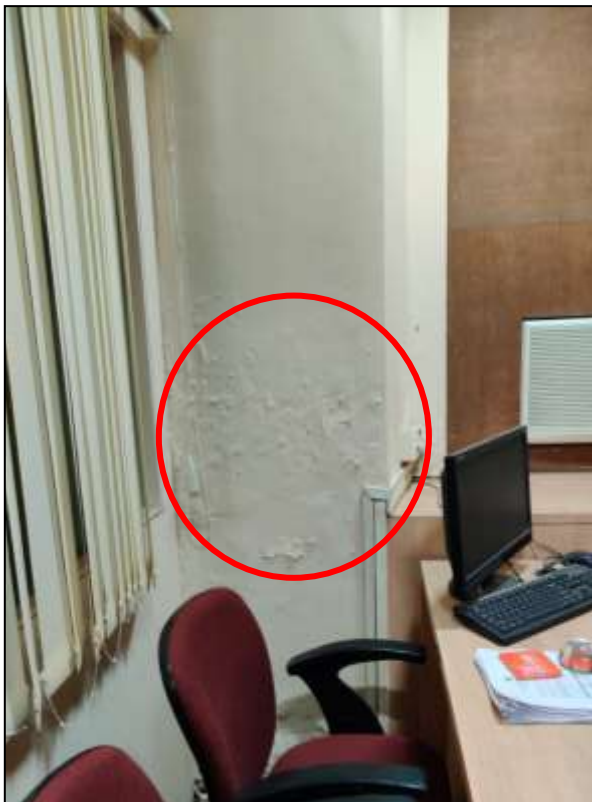
Fig 24. Leakage marks observed in Directors cabin 1st floor

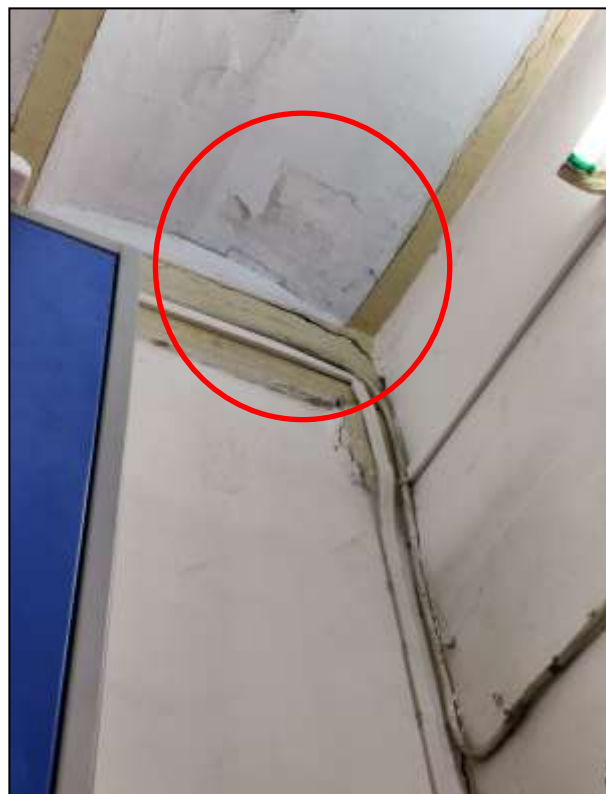
1. Leakage marks observed in Social Science Centre on external wall.
2. Peeling of paint in Hostel superintendent office (used as Department of History) Ground floor observed.
3. Dampness observed in the staircase area due to leakage from the external wall.

Fig 25. Dampness observed in staircase area

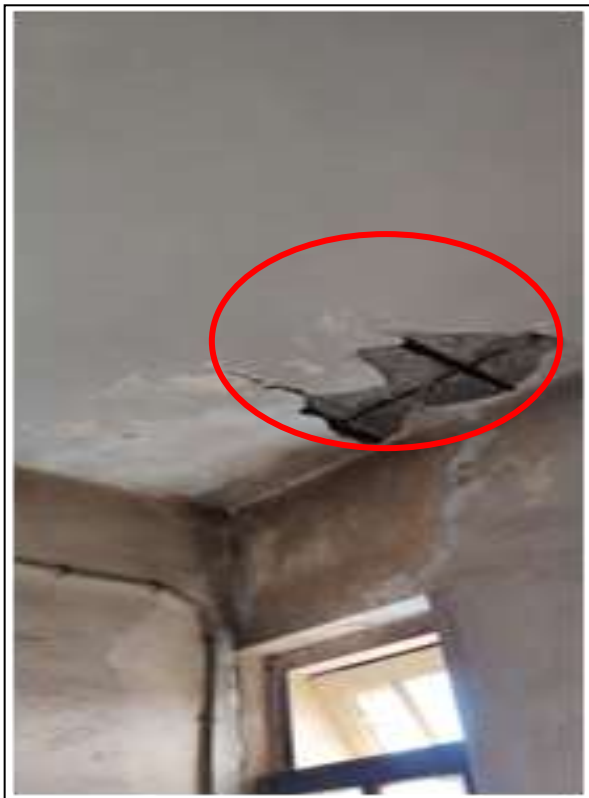
1. Cracks observed at mummy slab and beams and lift room slab and beams of Hostel Building.
2. Leakage & delamination of plaster in toilet area observed.
3. Major leakage observed in room no. 520.
4. Reinforcement is exposed in the slab of toilet area due to spalling of cover concrete.
5. Vertical crack in column is noted at second floor.

Fig. 26. Lift room exposed slab reinforcement

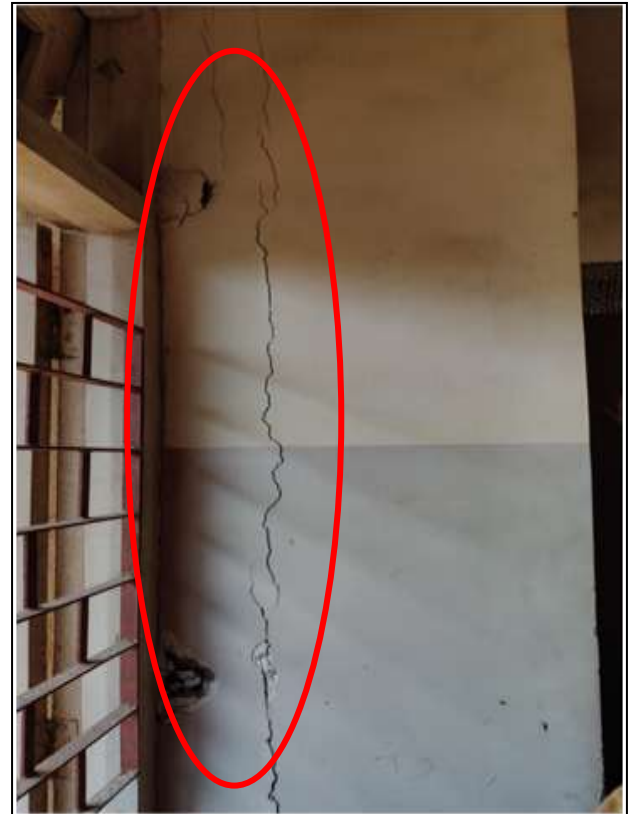
Fig. 27. Vertical crack in column 2nd floor

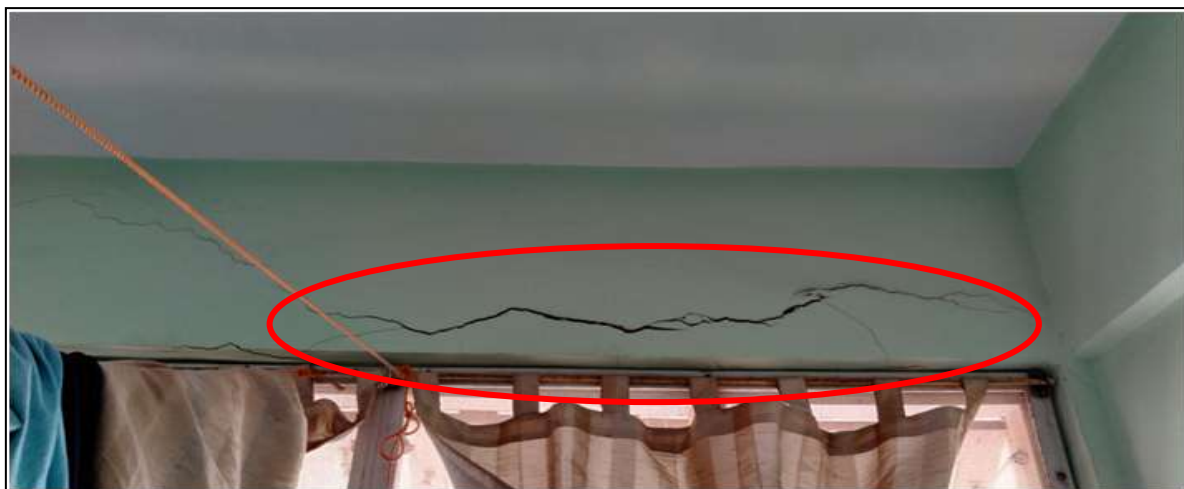
Fig. 28. Horizontal crack in Beam bottom in room no 414
